**Blythes Creek  
Recreational Use Attainability Analysis**

**July 2005**

**Prepared by:**  
**MEC WATER RESOURCES, INC.**  
1000 North College Avenue, Suite 4  
Columbia, Missouri 65201

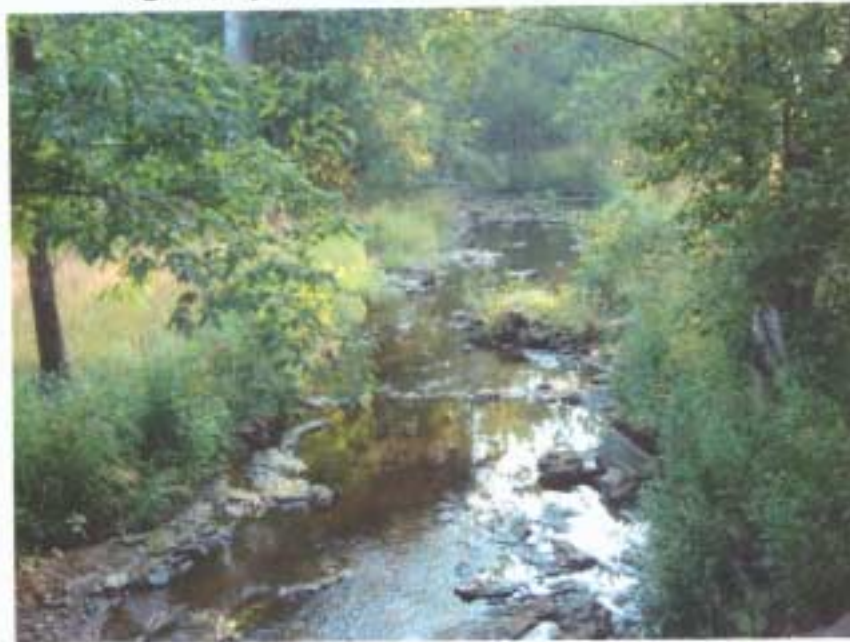
Figure 4. Blythes Creek Site 1 Downstream View

Mean depth along a 310 ft. assessment reach was 0.3 ft. as determined from 37 transects (Appendix B). The maximum depth observed at this location was 1.1 feet in a small pool within the assessment reach. Flow was measured as 0.40 cfs.

Livestock watering was the only sign of potential human use at this site. Fences impede access in the stream channel. The stream banks are gently sloping and not heavily vegetated and access to the stream is relatively easy. No individuals were seen or found to be available for interviews near the bridge during the survey.

MEC staff concludes that WBCR is neither an existing or an attainable use at this site based on limited access to the stream imposed by fences, absence of observed recreational uses, and low-flow, shallow conditions.

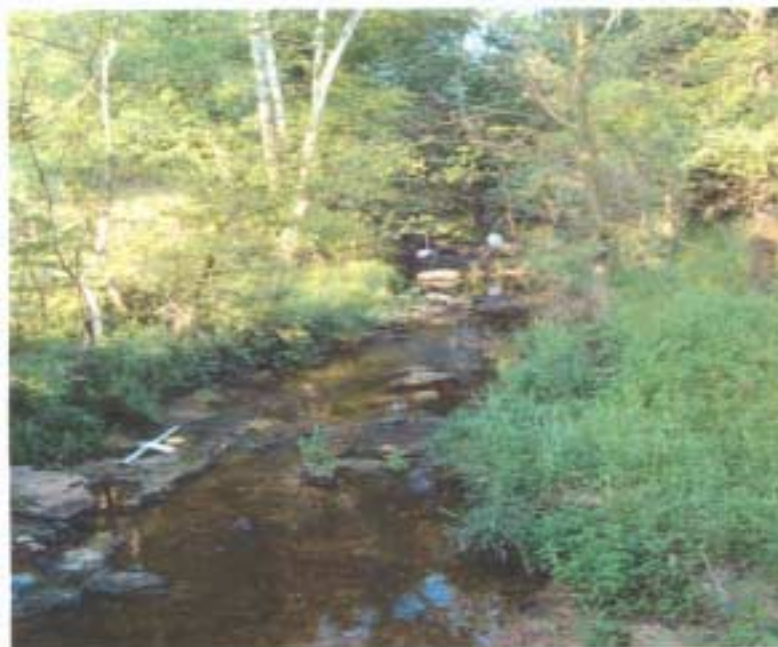
**Figure 3. Blythes Creek Site 1 Upstream View**

stream. Banks are gently sloping and are vegetated with grasses, shrubs, and taller trees (Figures 3 and 4). Riparian areas are composed of trees and shrubs with some cool-season grasses associated with the grazing pasture nearby. Channel substrate was predominately gravel with cobble, bedrock, and sand present. Filamentous algal growth was present on the substrate throughout the reach.

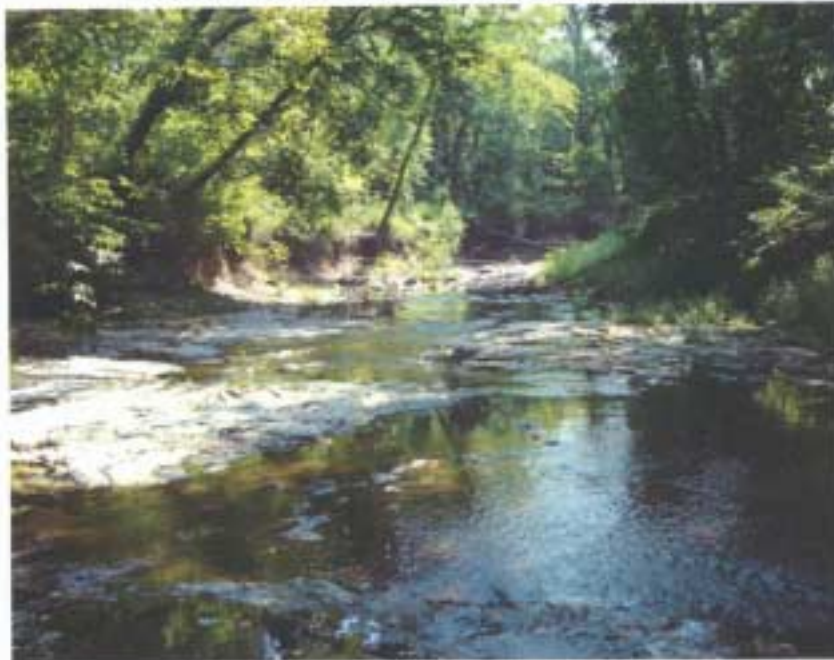
Figure 7. Blythes Creek Site 2 Downstream View

Mean depth along a 720 ft. assessment reach was 0.3 feet as determined from 29 transects (Appendix B). The maximum depth observed at this location was 1.4 feet in a small pool downstream of the road access. Flow was measured at 0.62 cfs.

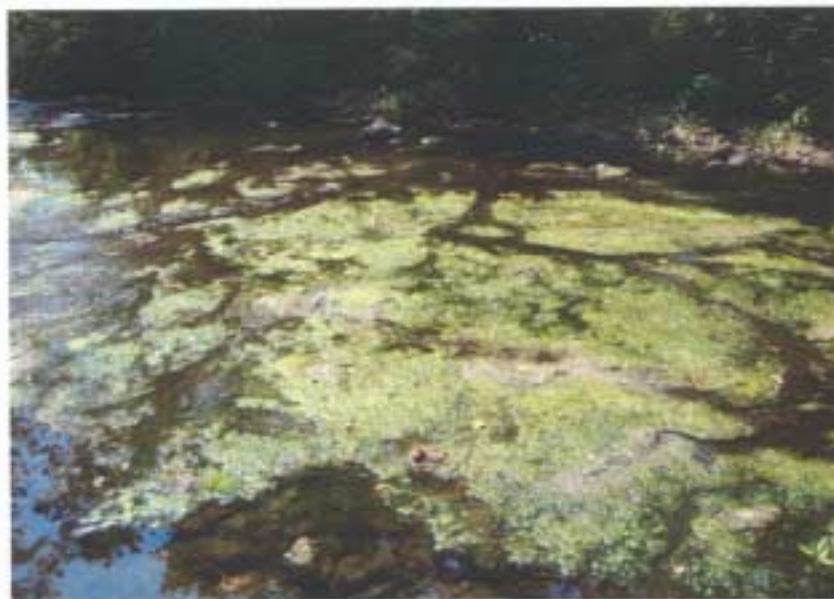
Figure 8. Blythes Creek Site 2 Algal Growth

The road crossing at Olean Road is located about 1.5 miles downstream from Site #1. Stream banks near the road are gently sloping and relatively easy to access (Figure 4). Riparian areas are wide and open and primarily vegetated by the upland deciduous forest complex (Figures 5 and 6). The stream channel was observed to be mostly bedrock with some cobble. Heavy algal growth was observed at this access point (Figure 7).

| A lot of algal growth - COVERED ROCK |

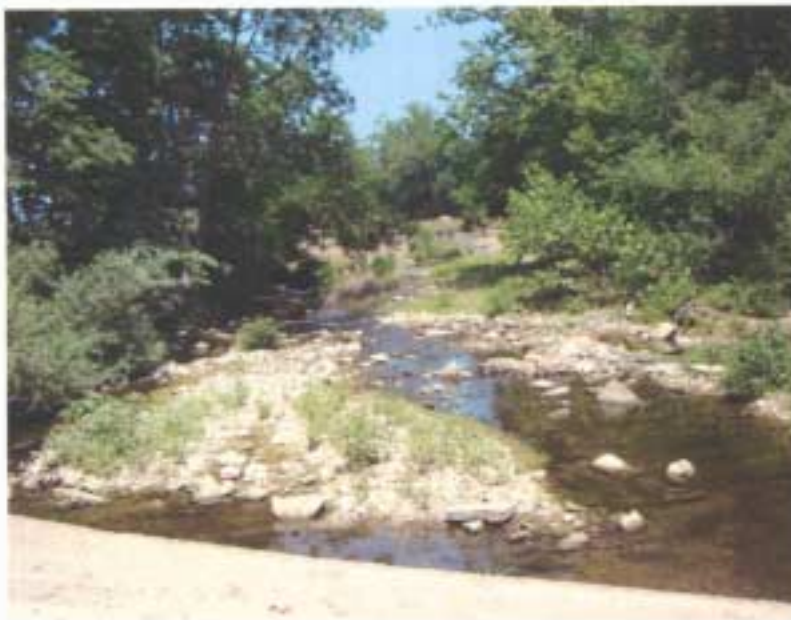
Figure 10. Blythes Creek Site 3 Downstream View

Mean depth along a 840 ft. assessment reach was 0.50 feet as determined from 24 transects (Appendix B). The maximum depth observed at this location was 1.52 feet in a pool downstream of the road access. Observed streamflow was 0.42 cfs.

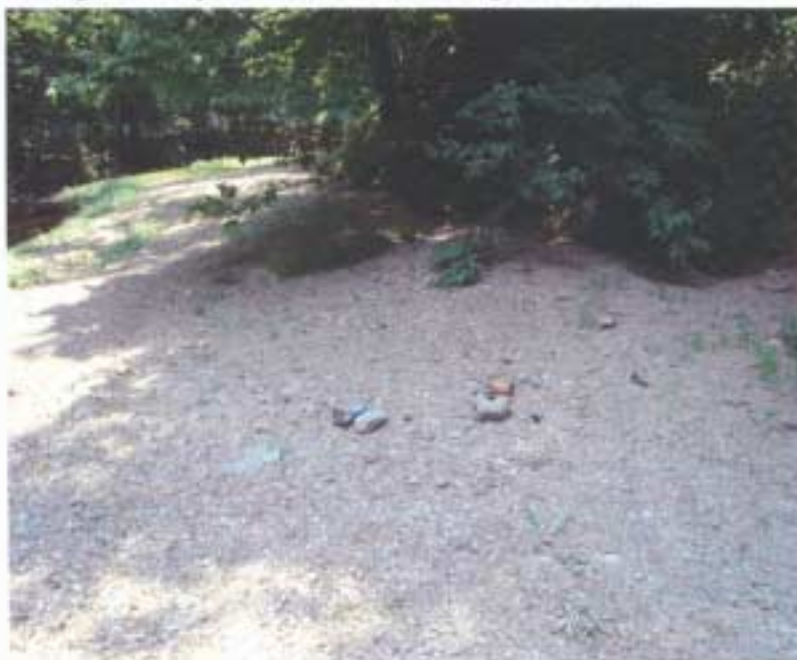
Figure 11. Blythes Creek Site 3 Garbage on Stream Bank

Upon arriving at the bridge crossing, MEC staff observed 3 children attempting to catch frogs and crayfish in the stream. All terrain vehicle tracks were also observed entering the stream at the bridge crossing. Garbage and food leftovers were observed about 100 feet upstream from the bridge crossing on a sandy area on the stream bank (Figure 8).
